"Visual Inspection" by Galen V. Govier

BS23V1B138119

1971 PLYMOUTH 440+6bbl 'Cuda 2 Door Hardtop VIN BS23V1B138119 is now in the Registry.

Herein is the summary of the visual inspection on the 1971 PLYMOUTH 'Cuda 2 Door Hardtop VIN BS23V1B138119 I did for you on May 04, 2006 at Jeff Resurrections in Taylor, TX.

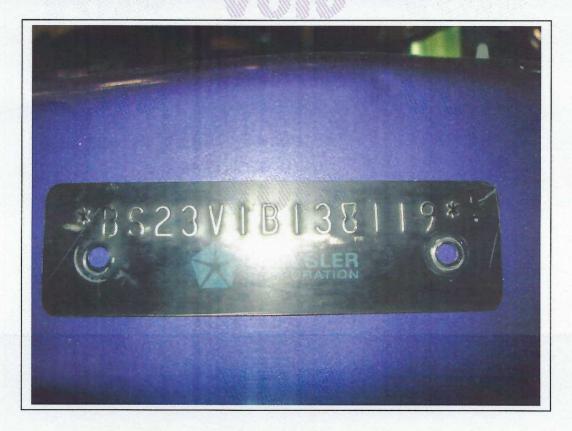
Verified as correct, off the car less rivets.

1. Dash VIN - Located on drivers side of the dash, visible through the windshield.

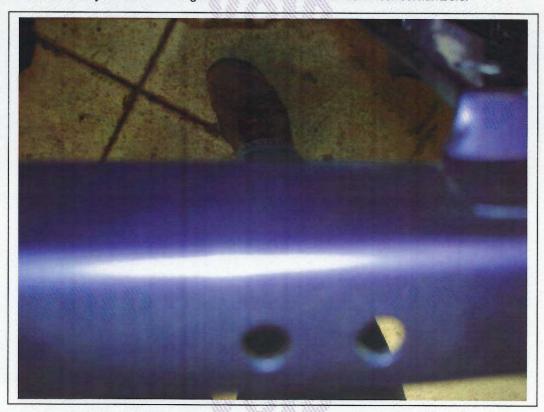
Not found on the back of the radiator support.

Primary body code-not found on the backside of the radiator support.
 A. Body code numbers include assembly plant, model year and last six digits of the VIN. NOTE: Panel may have been changed. No numbers are better than incorrect numbers.

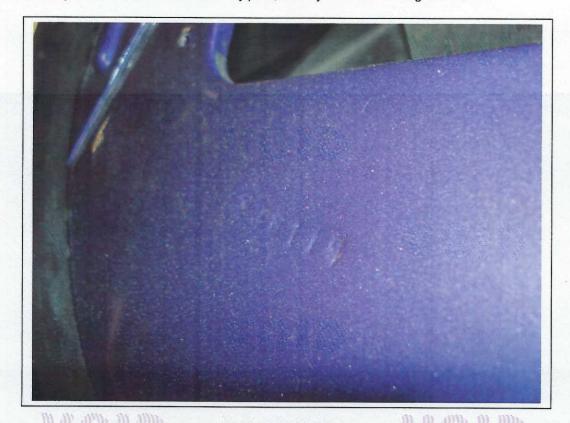
Verified as correct and in its proper location.

Secondary body code-typically found on the cowl, between the master cylinder and the windshield.
 Body code numbers include assembly plant, model year and last six digits of the VIN.

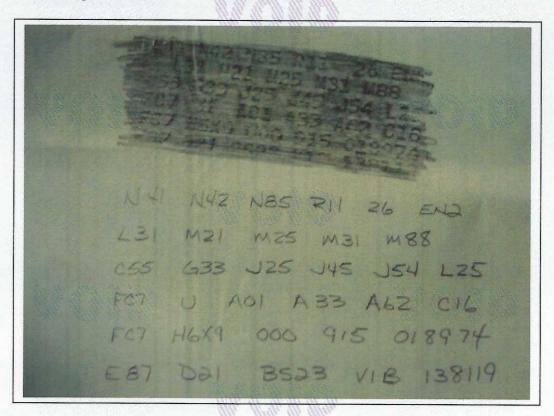
Fender tags-found underhood near battery, VIN is on the bottom row of the tag. Enclosed is a decoding of the fender tag and some related paperwork. The fender tag is off the car.

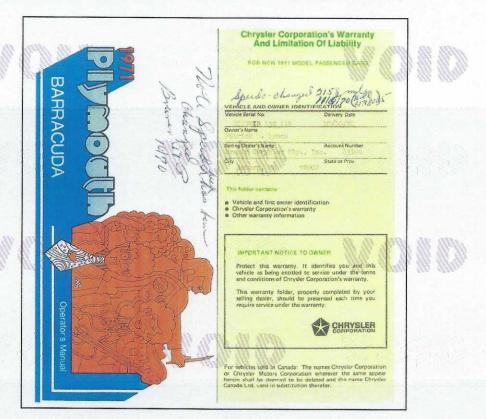
Photo of Owners Manual & Warranty brochure. (Speedometer changed @ 02,158 miles).

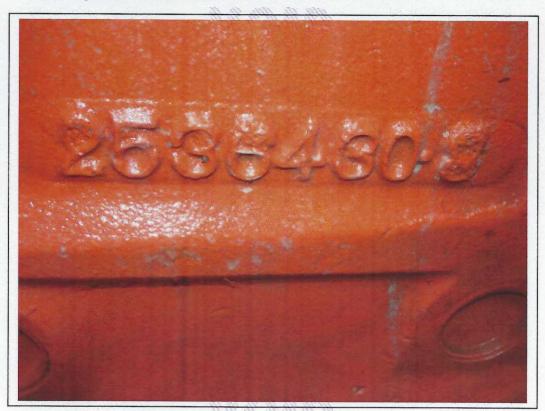
B. The casting number is on both sides of the block, below the head. The casting number is: 2536430-8.

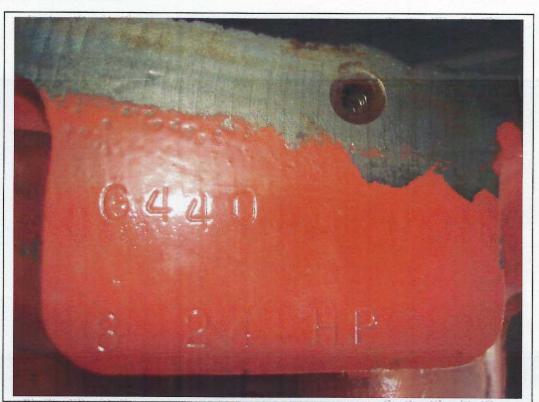
440 CID. There is also the engine ID stamped on the front of the block in front of the intake manifold. The meaning to the stamped numbers are G = Series 1971, 440 = Cubic inch displacement on the top row. 8 24 = August 24, 1970 Engine assembly date and HP = High Performance (385hp). THE 440 BLOCK IS AN "RB" ENGINE.

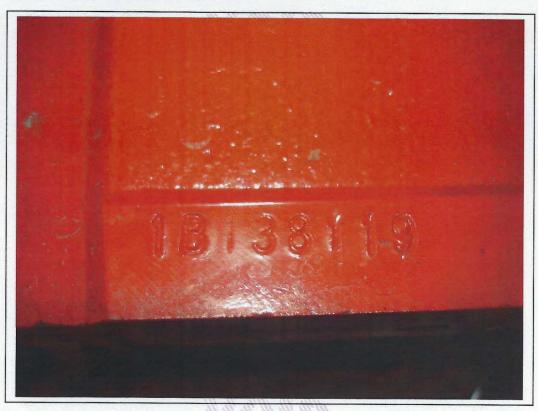
Verified as correct located on the engine block.

5. VIN stamped on engine-found on passenger side lower block. This is the original engine for the vehicle.

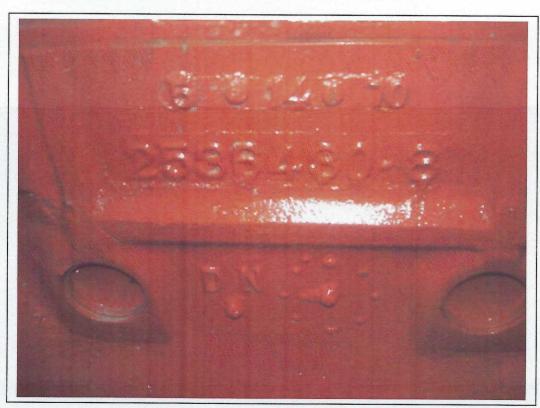
A. The casting date, casting number and clock are found on the passenger side of the block. The casting date is: 5-14-70.

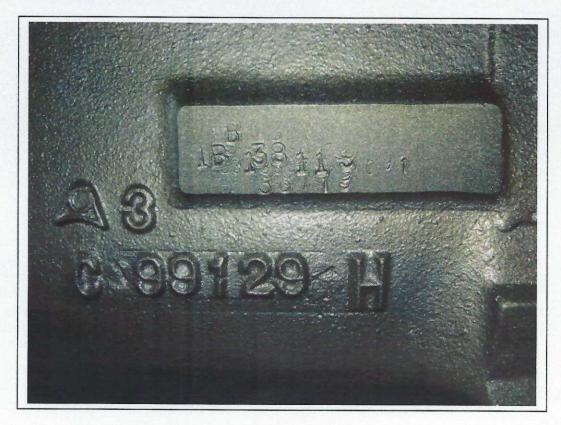
VIN stamped on Transmission-found on passenger forward side of the manual transmission case.
 A. The number PP=New Process, 833=4 Speed, 330? is the 10K date code, which decodes as September 09, 1970. The 091 is a sequence number. You can see the last 8 digits of the VIN on

This is the original transmission for the vehicle.

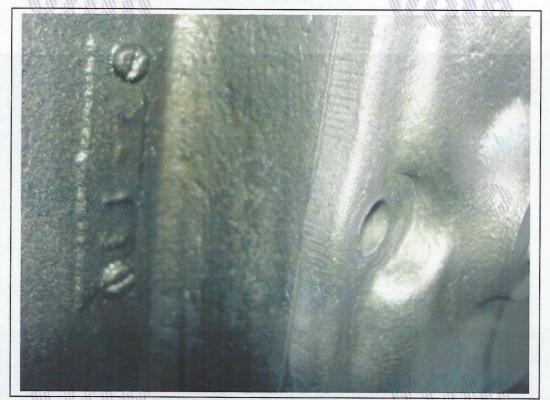
The casting date of the 4-Speed manual transmission is found on the drivers' side forward of the side cover. The date looks to be 4-13 (April 13, 1970).

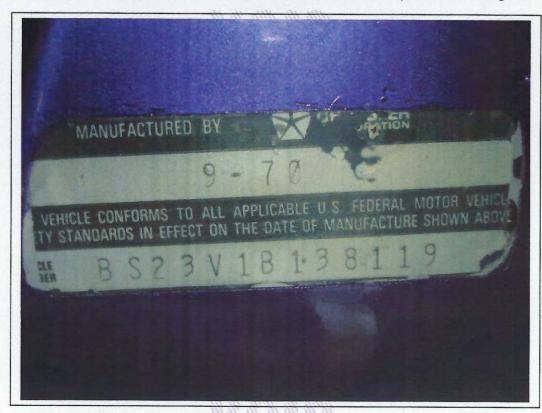
Verified as correct; an original decal.

7. Beginning in 1970, there should be a Door VIN decal-found on the backside of the driver's door. It will tell the month and year of manufacture. At the B-plant it is mounted horizontally. This decal is original.
